2021 BRANCH & DERBY INTERCOUNTY DRAIN WATER QUALITY REPORT

January 3, 2022

*Paw Paw Lake Special Assessment
Advisory Committee*

*Spicer Group
1400 Zeeb Drive
St. Johns, MI 48879
www.spicergroup.com*

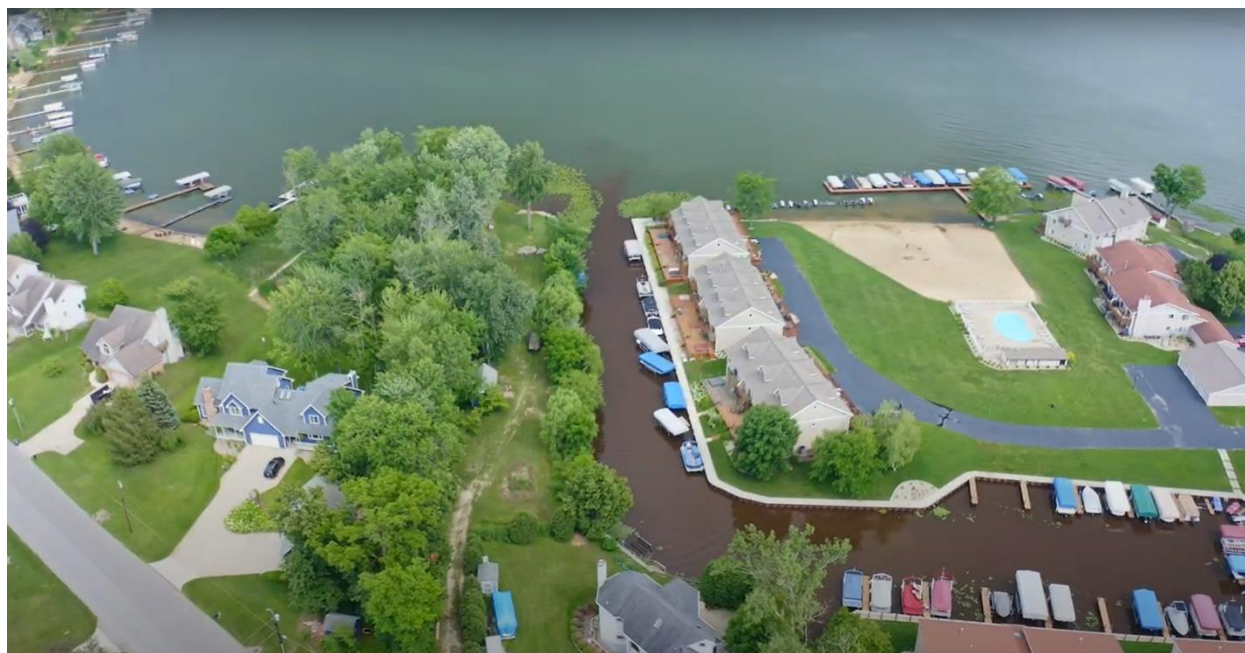
Figure 2 - Outlet of the Branch & Derby Drain to Paw Paw Lake. Note the color difference between Paw Paw Lake and the Branch & Derby Drain. The dark brown color is sediment, suspended and dissolved solids, and tannins conveyed through the drain. Photo taken on June 28, 2021. Photo Credit: Cody Krieger

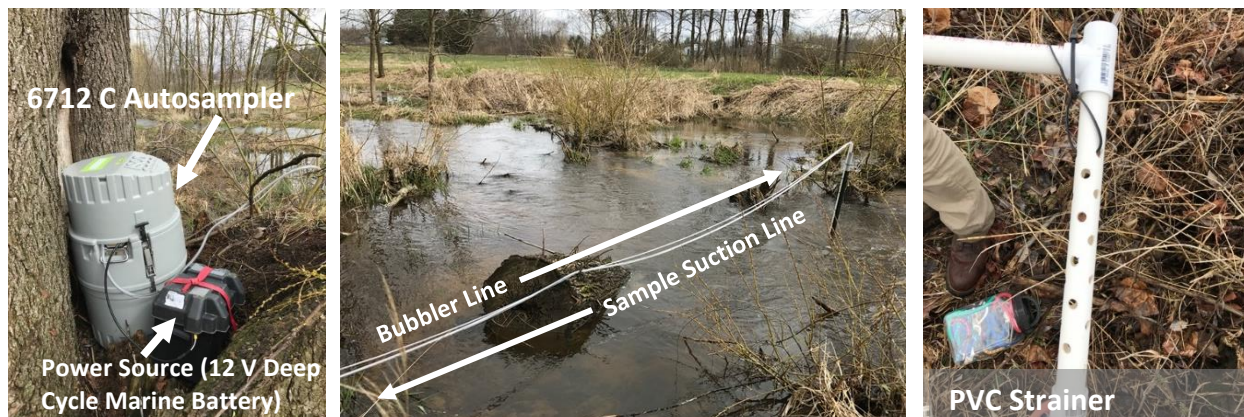
Figure 5 - Field installation of an autosampler on the Branch & Derby Drain (sample site A6). The autosampler is placed on an elevated, flat area, is connected to a power source (12 V deep cycle marine battery), suction line, and bubbler line. The suction and bubbler lines are installed in the drain's centerline and are encapsulated within the PVC strainer. The strainer ensures that when samples are collected through the suction line, nothing large like leaves, crayfish, etc. get stuck in the tubing. Similarly, the strainer protects the bubbler line from damage and a clogged line.

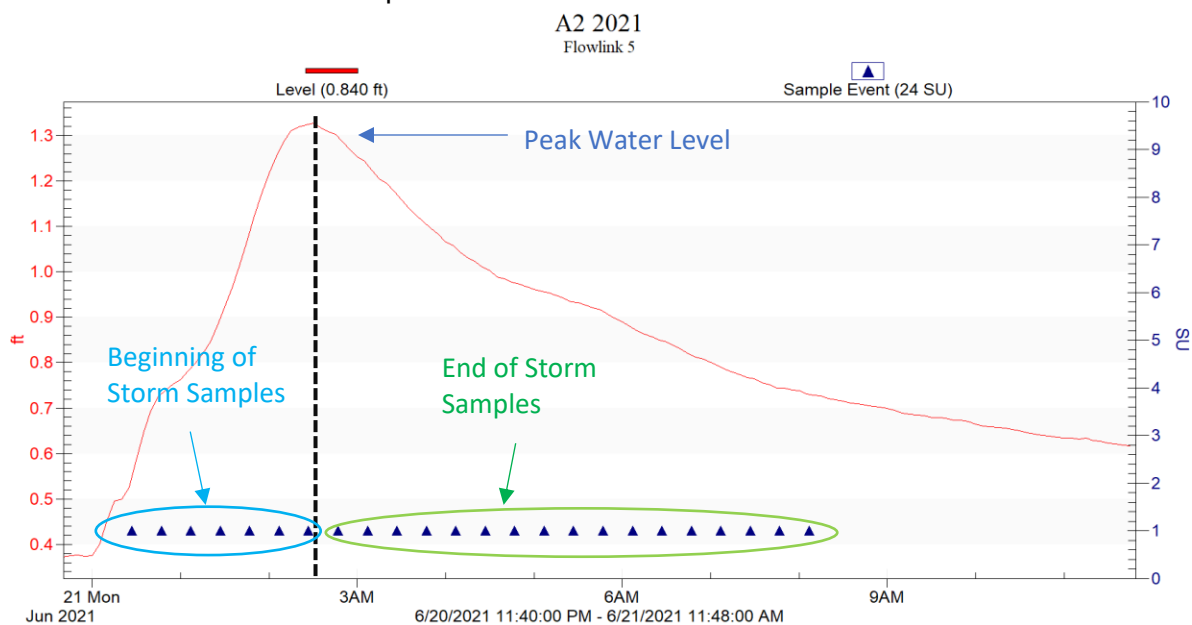
Figure 6 - June 21 - 22, 2021 sample event at sample site A2. The red line denotes water level (ft) in the drain at site A2, and the blue triangles denote when a sample was collected by the autosampler. The first seven samples were composited for the "beginning of storm" sample and the last 17 samples were composited as the "end of storm" sample.

In the Branch & Derby Drain, autosamplers were programmed to start sampling once the water level measured in the drain began to rise due to runoff from a rain event. When the water level increased by three inches, the autosampler started pulling 400 mL water samples every 20 minutes until each of the 24 bottles in the base of the autosampler were filled. When the sampler completed the sample event, field personnel went to each sampler, downloaded the data, and reviewed sample collection time compared to the curve in water level. The samples collected on the positive slope of the curve were composited. This sample was determined to be "beginning of the storm" samples. Samples collected on the negative slope of the curve were composited and determined to be "end of the storm" samples.

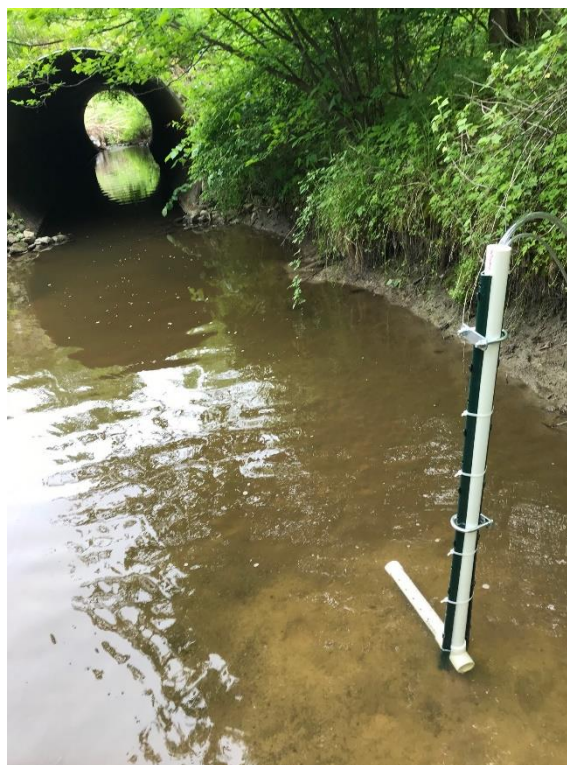
Figure 7 - Autosampler suction and bubbler lines installed on the Branch & Derby Drain, sample site A2, May 2021.

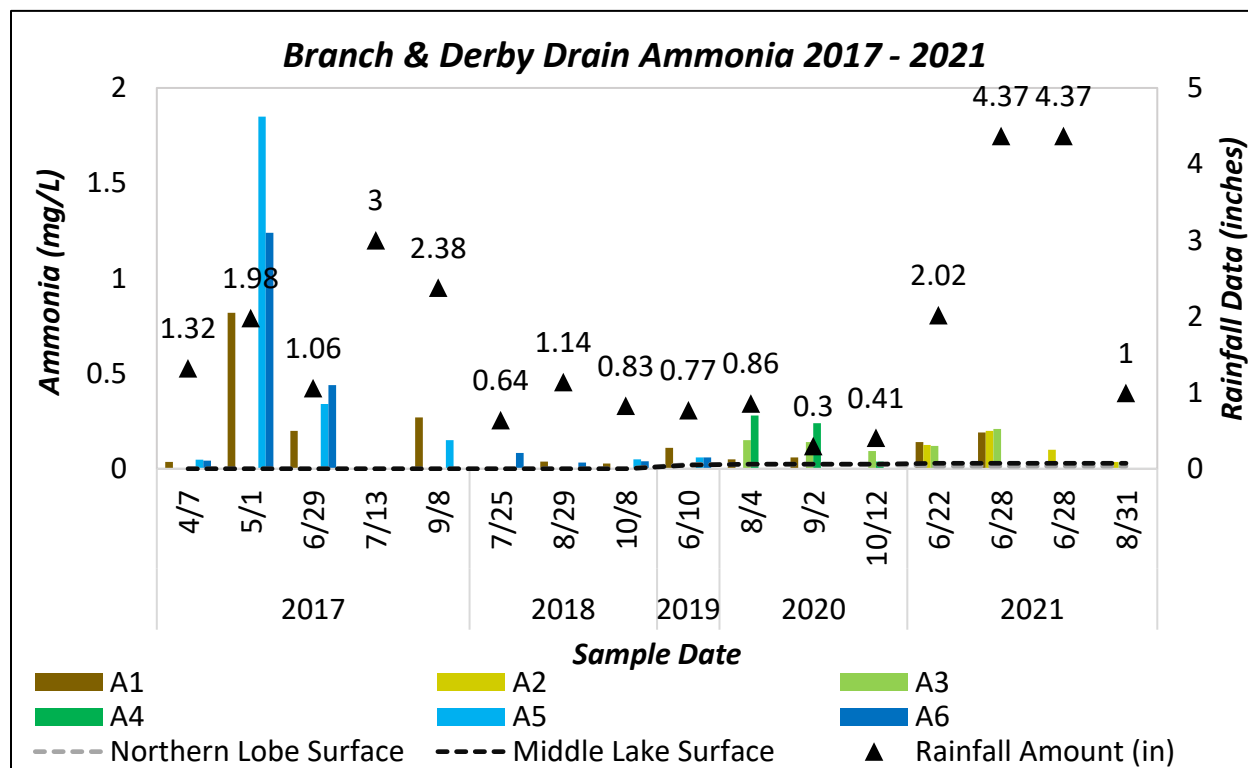
Figure 12 - Ammonia concentration measured in the Branch & Derby Drain during wet weather events over time. Data is compared to measured Paw Paw Lake ammonia concentrations over time.

Like all nutrients monitored in the Branch & Derby Drain, ammonia concentrations are much higher in the drain compared to Paw Paw Lake. Paw Paw Lake has had a concentration of ammonia ranging from "U" (which means a concentration near or at

zero) to 0.029 mg/L in the last 5 years of monitoring. By comparison, the drain has had concentrations of ammonia measured anywhere between 0.022 – 2.1 mg/L.

Again, no correlation between rainfall totals and ammonia concentration exists. Ammonia concentrations tended to be highest in the 2017 monitoring season and has not been as high since then. This may be due to the time of year that samples were collected in 2017, as it factored in the early part of the growing season in May, where other monitoring seasons did not. During some events, ammonia concentrations decreased the further downstream samples were collected, and other events the exact opposite was true; trends were inconsistent. Effort should be made to help reduce ammonia concentrations in the drain. This can be accomplished by responsible land management within the Branch & Derby Drain's watershed, removal of sediment from the drain, reconnection to the drain's original floodplain, detention basins, incorporation of native plant species in the design of basins and other best management practices.

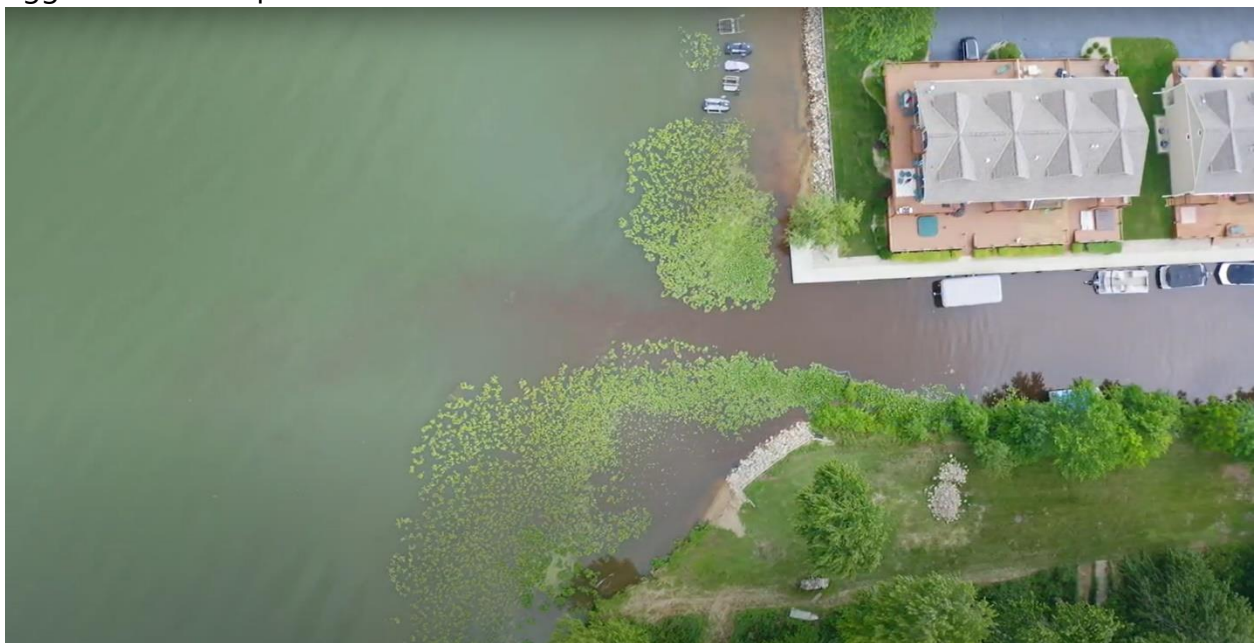
Figure 13 - Total suspended solids flowing into Paw Paw Lake from the Branch & Derby Drain. Image taken on June 28, 2021.
Source: Cody Krieger

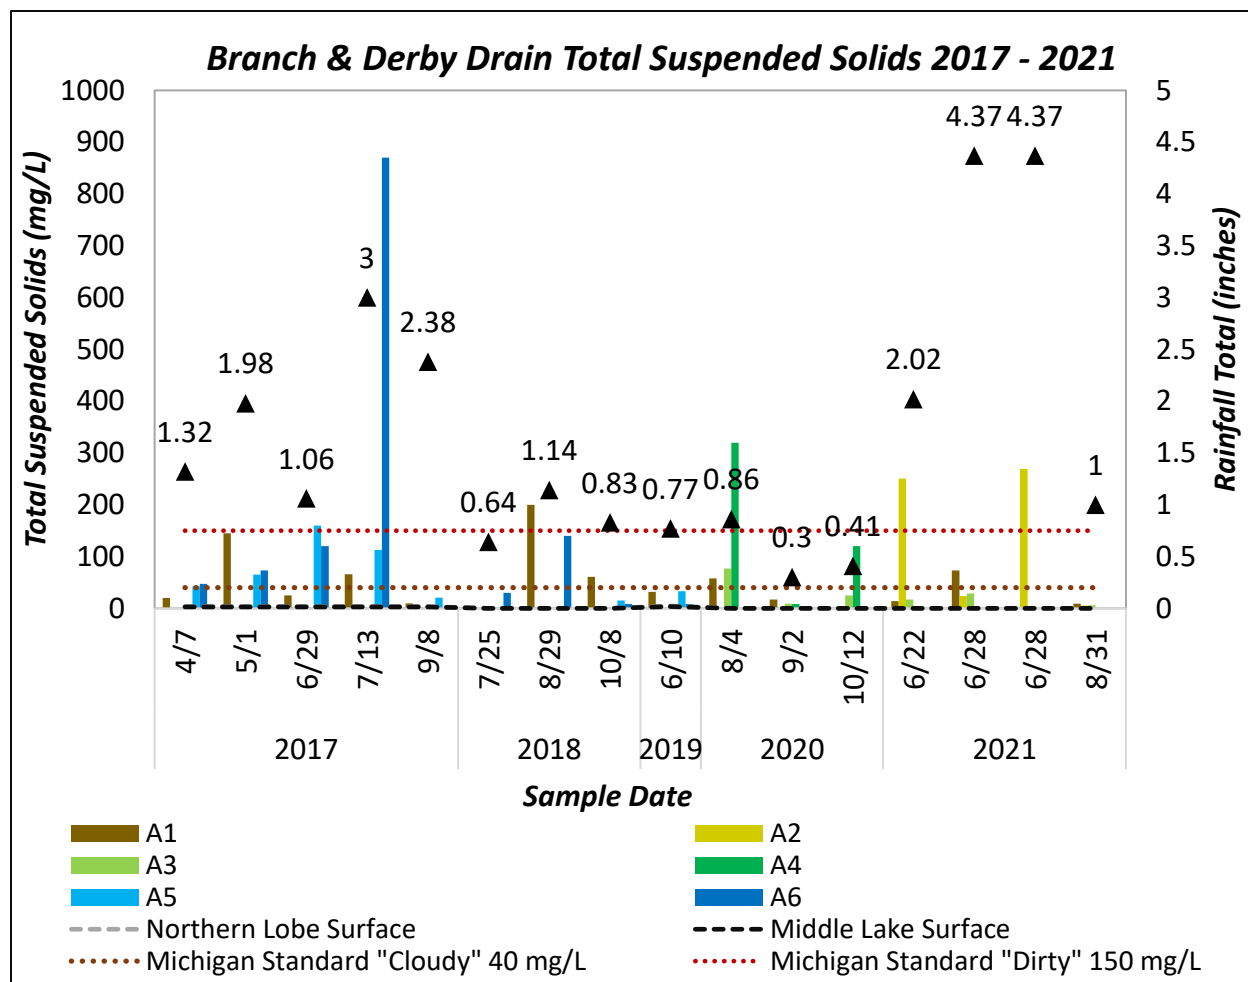
Figure 14 - Total suspended solids measured in the Branch & Derby Drain over time. Values are compared to the State of Michigan's narrative standard for TSS and values measured in Paw Paw Lake.

The State of Michigan has a “narrative standard” for TSS; meaning, the water should not have unnatural physical characteristics (MDEQ Rule 50, Part 4 of Act 451). Typically, water with TSS concentrations at >20 mg/L is clear, 40 – 80 mg/L is cloudy, and >150 mg/L appears dirty. Of all the samples collected in the Branch & Derby Drain, 51% of them were considered “clear,” 31% of samples were considered “cloudy,” and 18% of them were “dirty.” Results are shown in the graph below, along with rainfall totals for each event, Paw Paw Lake TSS concentrations on average, and State of Michigan guidance standards.

Following the same pattern as nutrients monitored, TSS did not have a strong positive or negative correlation with total rainfall. The highest concentration of TSS measured was on 7/13/2017 at site A6, with a concentration of 870 mg/L. A6 is the only sample site upstream of the M-140 detention basin. Effectively, the detention basin dropped sediment between A6 and the next sample site A5, which is located just downstream of the M-140 crossing and basin. The aerial images shown below (obtained from Google Earth) demonstrate how much sediment has been deposited in the basin over time since its construction.

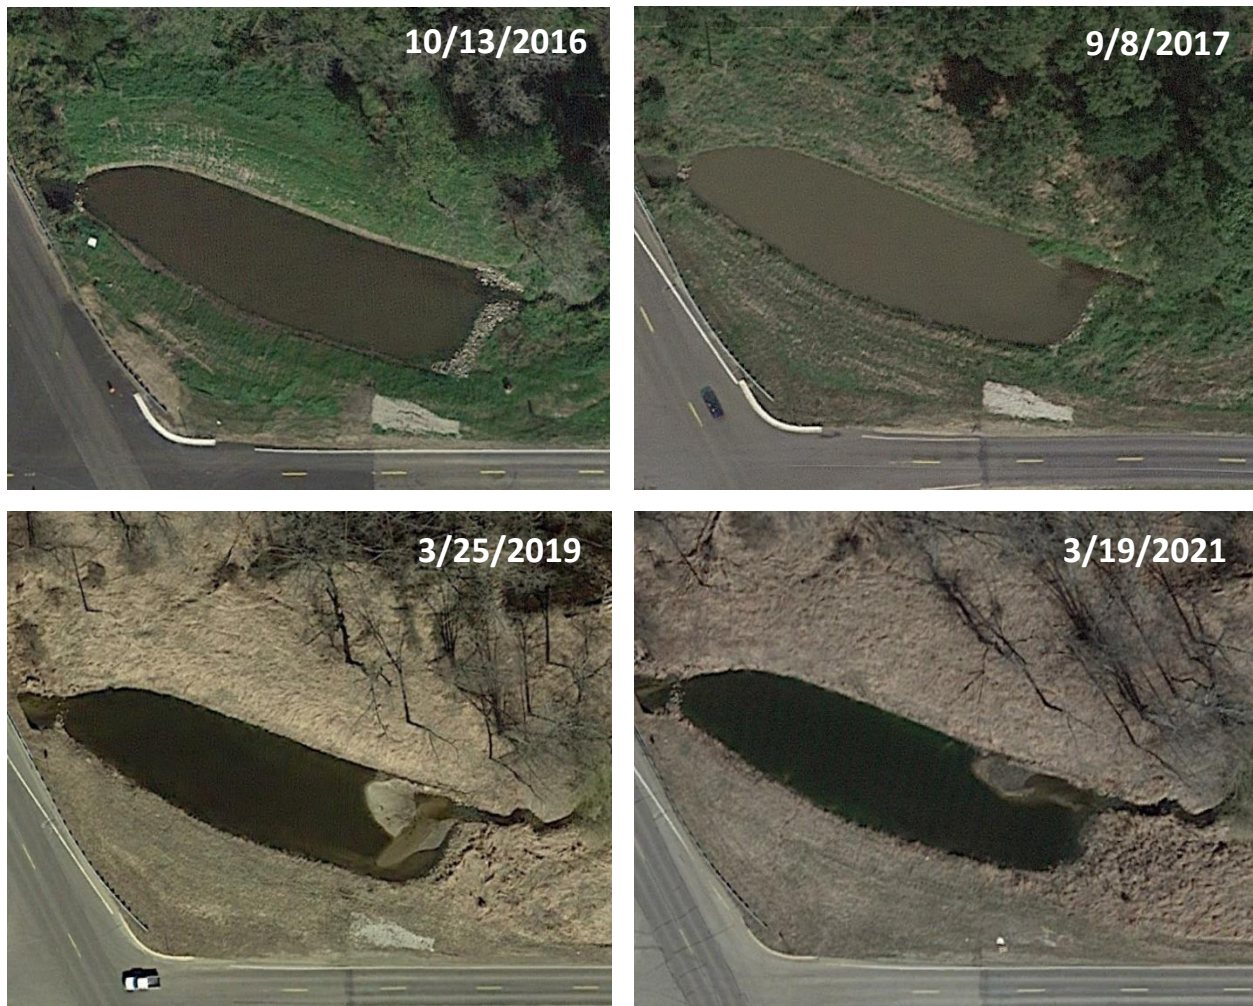
Figure 15 - Aerial view of the M-140 basin on the Branch & Derby Drain. Note the sediment deposition in 2019 and 2021 images.

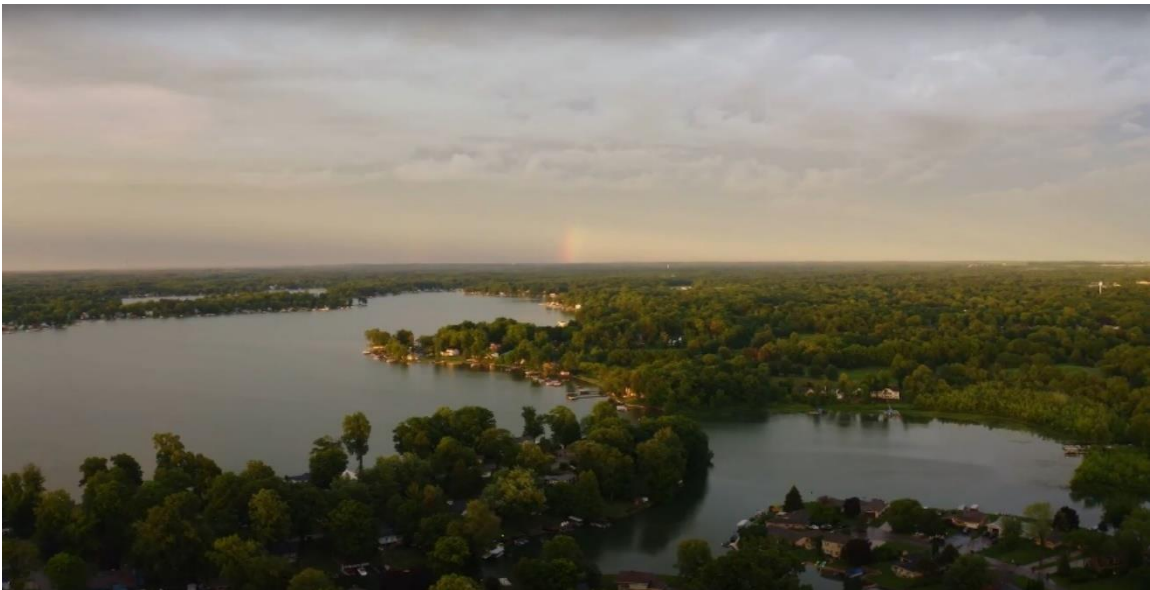
Figure 16 - View of Paw Paw Lake and its watershed after a rainstorm. Photo taken on June 26, 2021. Source: Cody Krieger

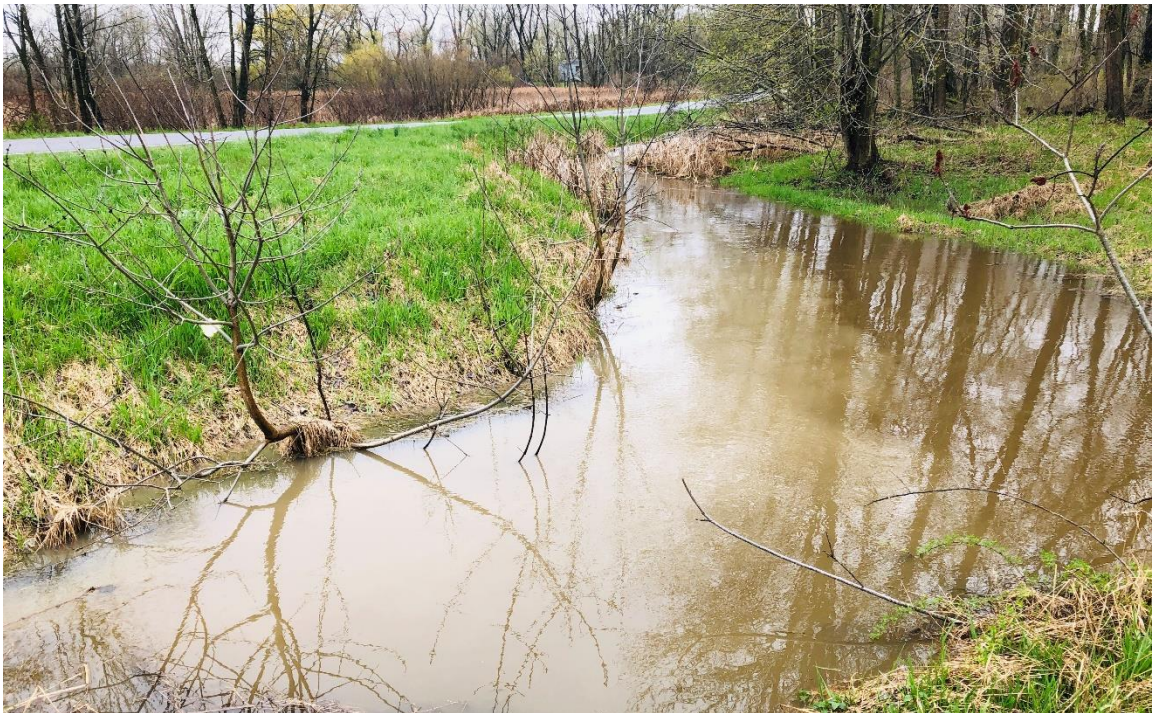
Figure 17 - Confluence of Branch & Derby Drain and Green Drain near Hagar Shore Road. Photo taken on April 29, 2020. Source: Spicer Group.

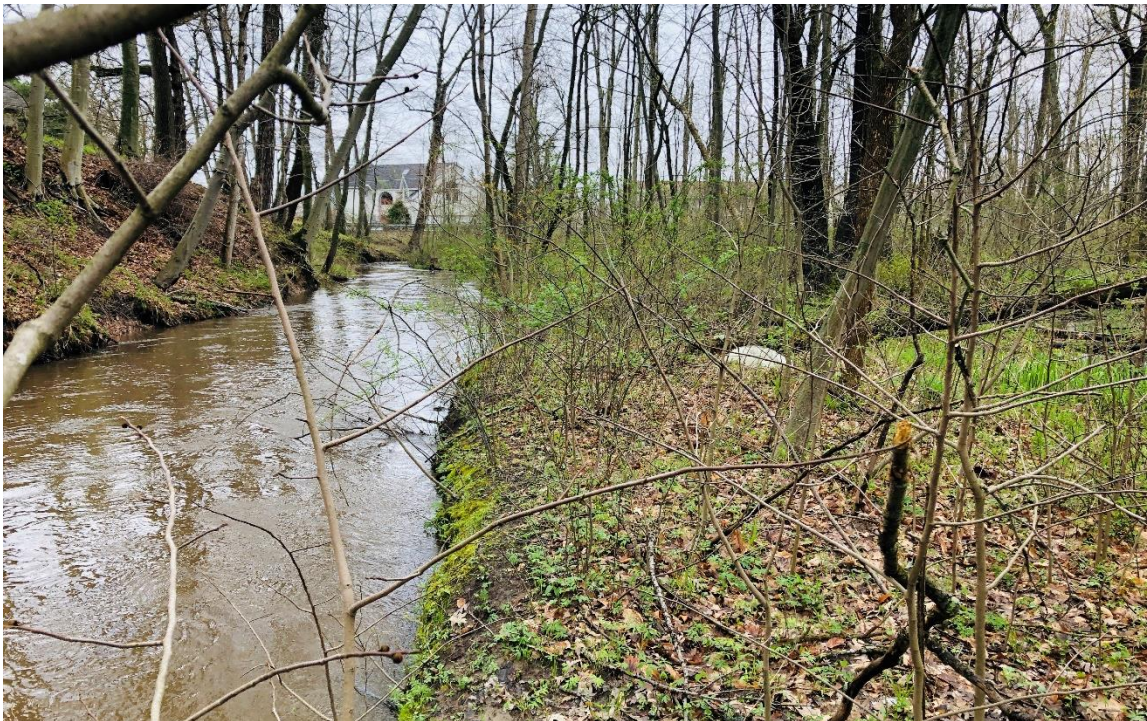
Figure 18 - Lower Branch & Derby Drain near outlet to Paw Paw Lake. Note that the drain is not connected to the floodplain at this location. Photo taken on April 29, 2020. Source: Spicer Group.
